Case Study: Exterior Application of Madewell's Crack-Bridging Laminate System in Albany, IN

Contractor: Culy Contracting, Inc.
Location: Albany, Indiana
Structure: 6,000 square foot concrete brine tank
Year: 2005, 2013

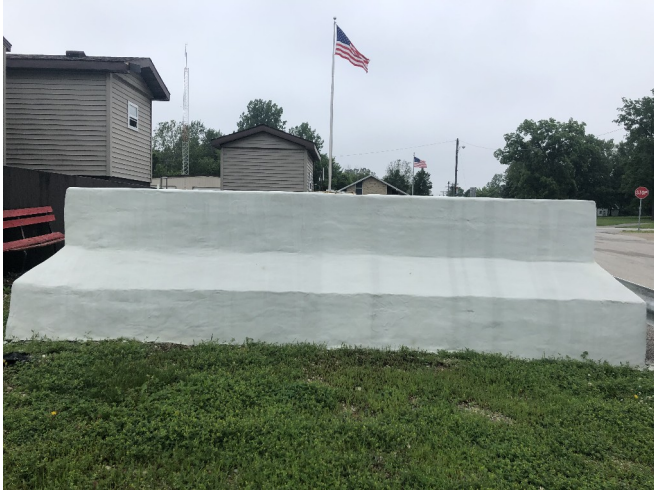
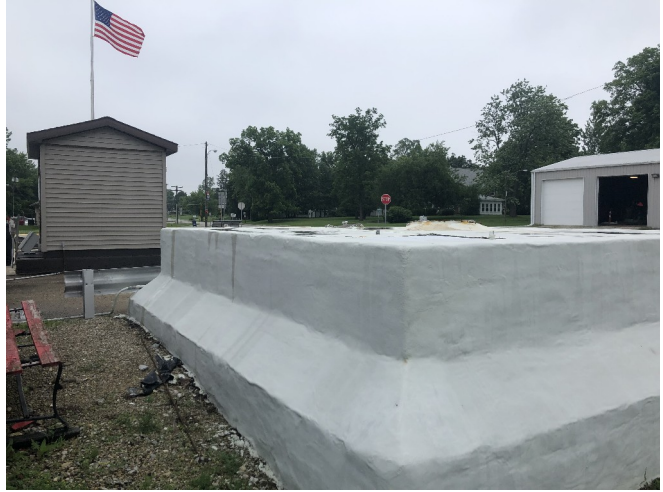
Over the years, the exterior of the brine tank underwent numerous freeze/thaw cycles. This resulted in more cracking on the outside of the tank, and in 2013, Culy Contracting was brought in to resolve the issue. The crew began by using a grinder to roughen the surface and remove any loose material. After surface preparation, a thick coat of Madewell 1312P Epoxy Putty was applied to bridge the existing cracks and smooth the substrate. One layer each of fiberglass mat and cloth were laid over the wet Madewell 1312P using rollers to remove any air voids between the

The tank was reinspected in June of 2019. The utilities department head said the lining was holding up well and reported no further issues.

epoxy and fiberglass layers. The fiberglass was then saturated with Madewell 1312E Epoxy Saturant (Resin) using a paint roller. The lining was left to cure overnight.

The next morning, any loose fiberglass strands were removed using a grinder. Denatured alcohol was used to wipe away contaminants that may have formed on the surface overnight. Then, Mainstay DS-5 Epoxy Coating was applied at 60 mils to cover the fiberglass.
